Managing MILCON and Munitions

Moving Target Mortar Range-North/South, Dam Neck Annex

Lance Laughmiller NAVFAC MIDLANT

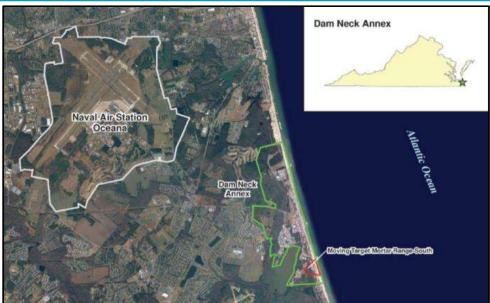
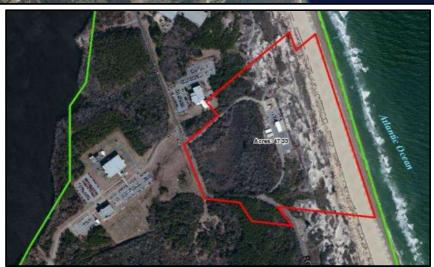
- The Preliminary Assessment identified the area as a "suspected" MEC area
 - Two moving target machine gun ranges were present in the southeastern portion of Dam Neck Annex, as observed on 1942 and 1943 aerials
 - Ranges were replaced by two mortar ranges after 1943
- No records documenting munitions use were found for the Moving Target Mortar Range – South (MTMR-S)
 - Munitions estimated based on the range boundaries and time period of use
 - Assumed .30 and .50 caliber small arms ammunition (SAA) and 60-mm and 81-mm mortars fired at site
- In 1960 facility constructed on site, no documentation of UXO removal associated with construction.

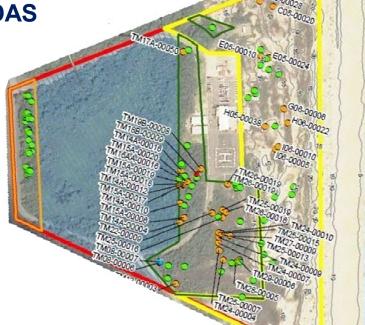
Investigation History

- 2010 Site Inspection
 - No MEC found on the ground surface

(4) 81-mm projectiles found in the subsurface (up to 18" below ground surface)

All projectiles ultimately classified as MDAS

- 2013 Present Remedial Investigation
 - DGM survey identified 2,496 anomalies
 - Intrusive investigation of 735 anomalies:
 - (1) 60-mm, M49A2 projectile (fuzed) classified as MEC (10" below surface)
 - (49) 60-mm projectiles and (2) BDU-33s classified as MDAS
 - (199) expended SAA
 - Investigation put on-hold until MILCON construction complete

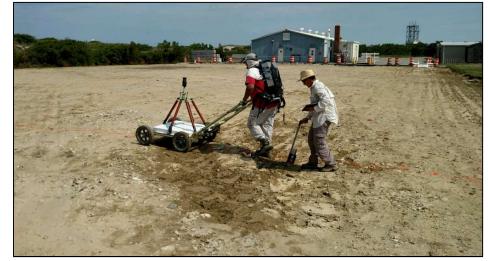
Follow on 'intrusive activities' outside of the 'cleared' areas to be conducted

with Construction Support

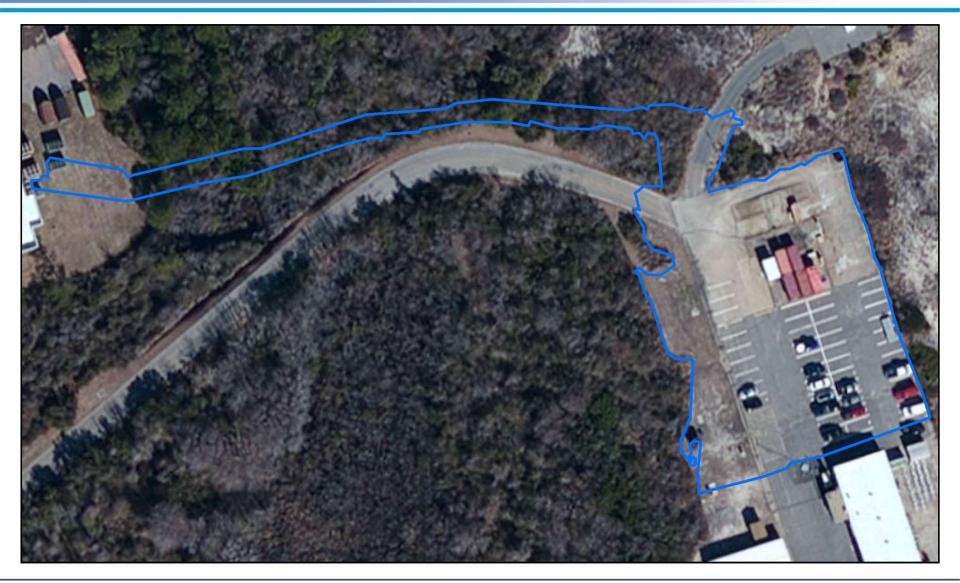
"Cleared" Area - Provided to MILCON

- September 2015: UXO contractor provided MILCON contractor a figure showing footprint of cleared area without sufficient context.
- September 2015 May 2016: MILCON contractor conducted general grading and removal of subsurface wooden pilings without construction support
- May 2016: MILCON contractor operating excavator identified a mortar in the teeth of the bucket when performing grading/earthwork along the edge of the asphalt cut in May 2016
 - Operator recognized potential MEC as a result of previous experience
 - MILCON contractor did not fully understand the horizontal and vertical limits of what they could do on the site.
 - EV/UXO contractor thought only minor grading was needed and then all effort would be built up
- Construction stopped until path forward could be identified

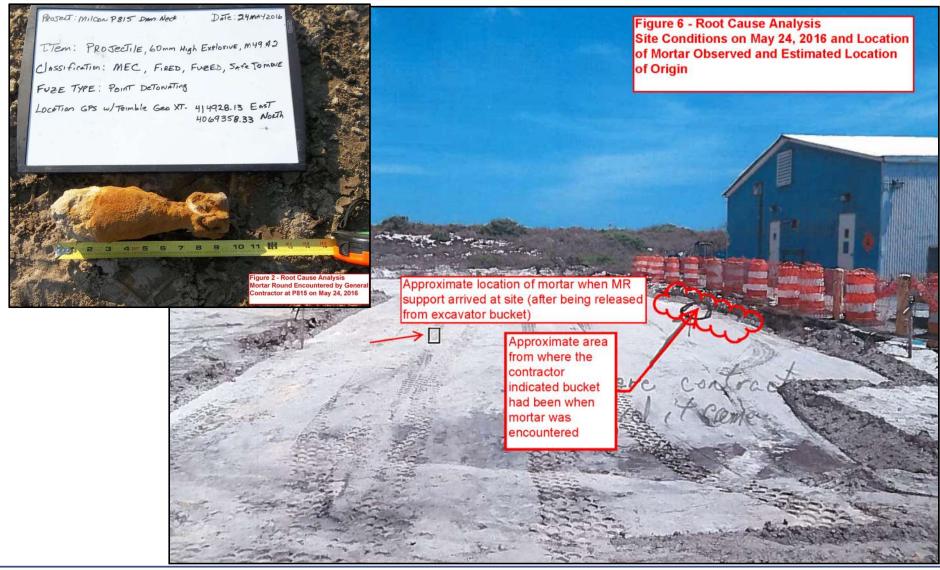
Post Incident RCA Site Photo

- A modified RI investigation process was used instead of a removal action to clear the site
- Failure to communicate actual extents of all intrusive efforts required for construction (means and methods)
- Several steps in the process indicated the approach would not be successful to meet MILCON needs were overlooked
 - Max depth of AGC detection for 60mm is ~26 inches, depth of removal for project up to 36 inches
 - Data Usability Assessment identified that the max reliable depth of detection was only 15.5bgs
 - AGC was conducted without removing base material for pavement, adding 4-6 inches of separation between items and sensors

- Clear failure of communication between EV, CI, CM, and contractors
 - CM/CI/MILCON contractor failed to accurately communicate all intrusive/excavation requirements for construction (pilings, unsuitable soil, subbase for footings, grading,etc.)
 - Footprint of AGC (TEMTADS) investigation not provided in adequate detail to CM/CI/contractors/subcontractors
 - Need for continued construction support not completely received by CI
- MILCON not adequately prepared for work on a MR site
 - Personnel believed that all MEC issues had been addressed
 - MILCON contract did not identify all intrusive activities
 - MILCON contractor did not understand ESS and associated work approaches and limitations
 - Site controls (stakes/markers) were inadequate or temporary and easily removed/modified by ... anyone

- NAVFAC EV conducted a time-critical removal action (TCRA) via RAC to address MEC within the Phase 1 area
 - TCRA consisted of DGM followed by soil removal in 12-inch lifts to a depth of 36" into the native soils
 - Lines of evidence suggested the 36" clearance depth is protective for construction activities and future use
 - A TCRA-specific MEC-QAPP and ESS were prepared for the project
 - Removal action took approximately 4 months to complete
 - Additional MEC was recovered at depths up to 28 inches into the native soil (most 12"-24")
- TCRA will be performed for the Phase 2 Area (anticipated June 2018)

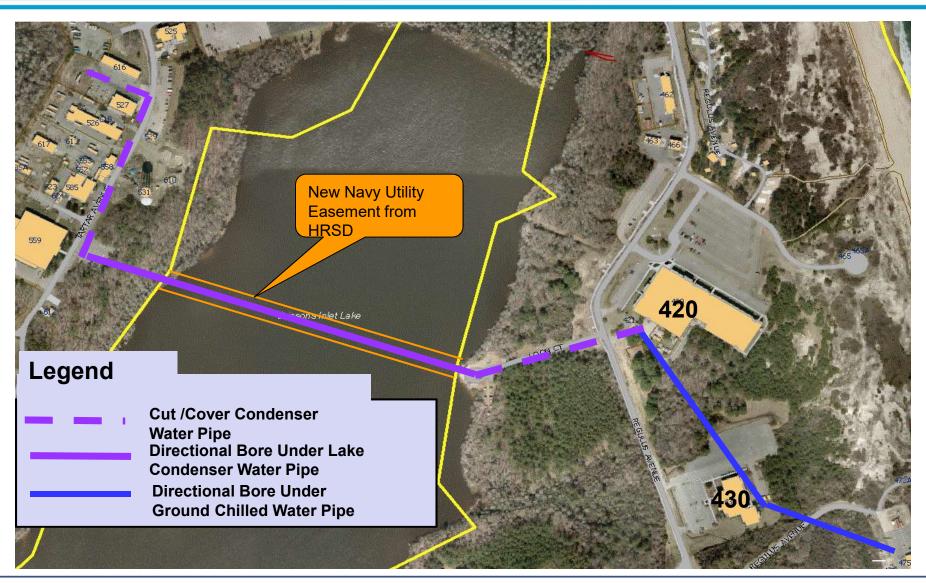
ESPC South Loop Expansion

- Extend existing Condenser Cooling Water Loop (Cooled by Hampton Roads Sanitation District effluent) to Building 420 by directionally boring a 20" line
- Install new chillers at building 420 and directionally bore an 8" chilled water line to over to building 430 to replace existing chillers

- Locations where the borings would pop up into the UXO area down to 36" below ground surface (BGS) based on ESS determination of hazard zone for the mortar impacts
- Angle of boring pop up to determine when it would enter the UXO potential impact zone
- Vertical and horizontal cleared area required to set boring machine
- Additional area(s) required to reset boring machine if they hit refusal
- Potholing required to accurately locate utilities that would have to be navigated
- Ground disturbance associated with mobilizing equipment, laydown areas and soil screening and stock piling areas
- Ground disturbance to get crane and other equipment adjacent to building to remove old chillers from building
- Areas to stage and fuse pipe for directional bore, dragging could cause surface disturbance
- Ground disturbance for equipment laydown areas

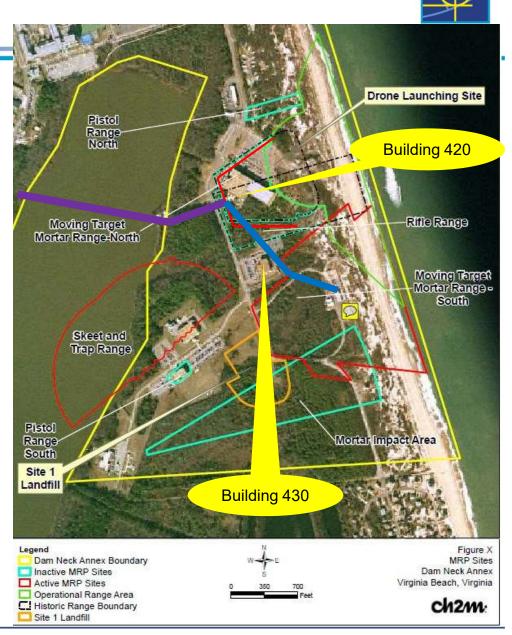
Areas of potential MEC impact:

- Location where cooling loop borings surface in moving target mortar range north.
- Locations where chilled water lines surface and potential tie in points for the chillers in in moving target mortar range north

- Step 1 Clearly define all aspects of the project that could require intrusive activities
- Step 2 Meet with contractor and FEAD on site
 - Include all subs performing work and the UXO contractor
 - Walk through detailed discussion of means and method for the construction
 - Ensure all parties understand the UXO hazards and what needs to be done to clear the site
 - Discuss any actions that could result in any penetration of the soil or ground disturbance like heavy equipment
- Step 3 Address all UXO clearance requirements in ESS and complete CERCLA documentation
- Step 4 Provide for follow on UXO support to address unforeseen conditions during drilling operations to avoid shutdown
